# SERVICE INFORMATION

**MDX-650**

**Spindle lock and Abnormal noise  
(Change in Flange shape)**

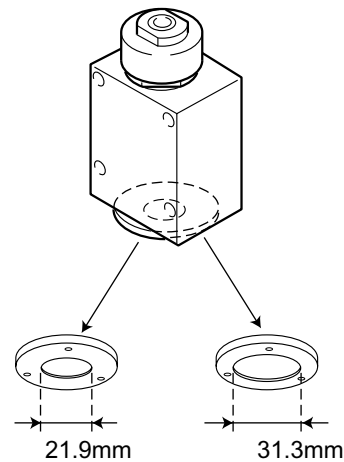
The bore diameter of the flange has been changed to prevent milled dust from collecting between the flange and the spindle.

**Current FLANGE**

Parts No. 21995116-00

**New FLANGE**

Parts No. 21995116-01

For users who use material such as coolite, replace the flange when you visit your customers or the above problems occur.
